HOME
report

SINGLE SURVEY
ENERGY REPORT
PROPERTY QUESTIONNAIRE
VALUATION REPORT

Single Survey

| Property Address | 62 Watermill Road Fraserburgh AB43 9RJ |

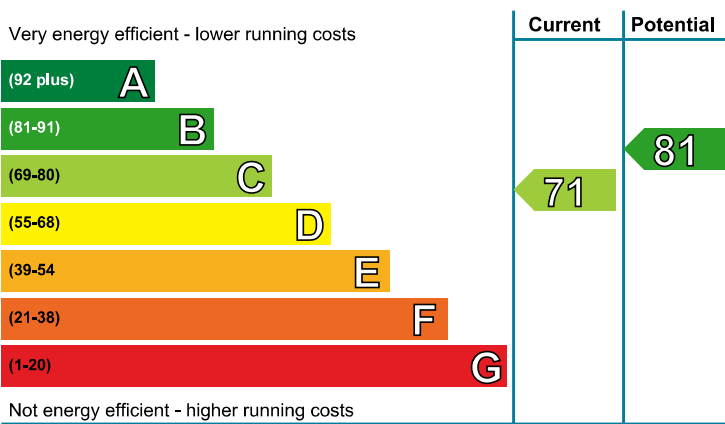
Energy Efficiency Rating

This graph shows the current efficiency of your home, taking into account both energy efficiency and fuel costs. The higher this rating, the lower your fuel bills are likely to be.

Your current rating is **band C (71)**. The average rating for EPCs in Scotland is **band D (61)**.

The potential rating shows the effect of undertaking all of the improvement measures listed within your recommendations report.

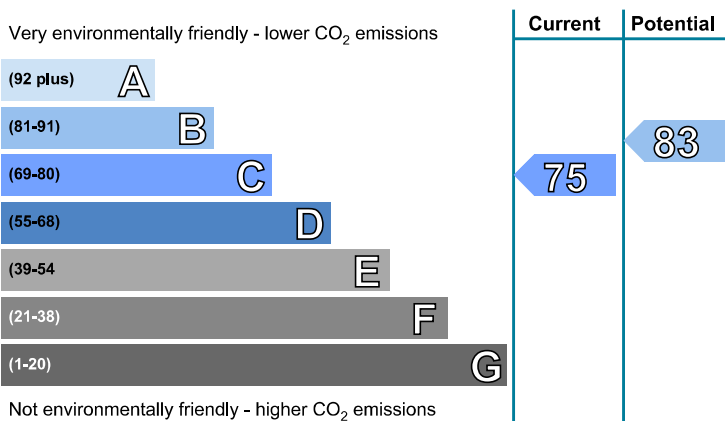
Environmental Impact (CO₂) Rating

This graph shows the effect of your home on the environment in terms of carbon dioxide (CO₂) emissions. The higher the rating, the less impact it has on the environment.
