# Single Survey

survey report on:

| <b>Property address</b> | 49 Grattan Place,<br>Fraserburgh,<br>Aberdeenshire,<br>AB43 9SD |

| <b>Prepared by</b> | DM Hall LLP |

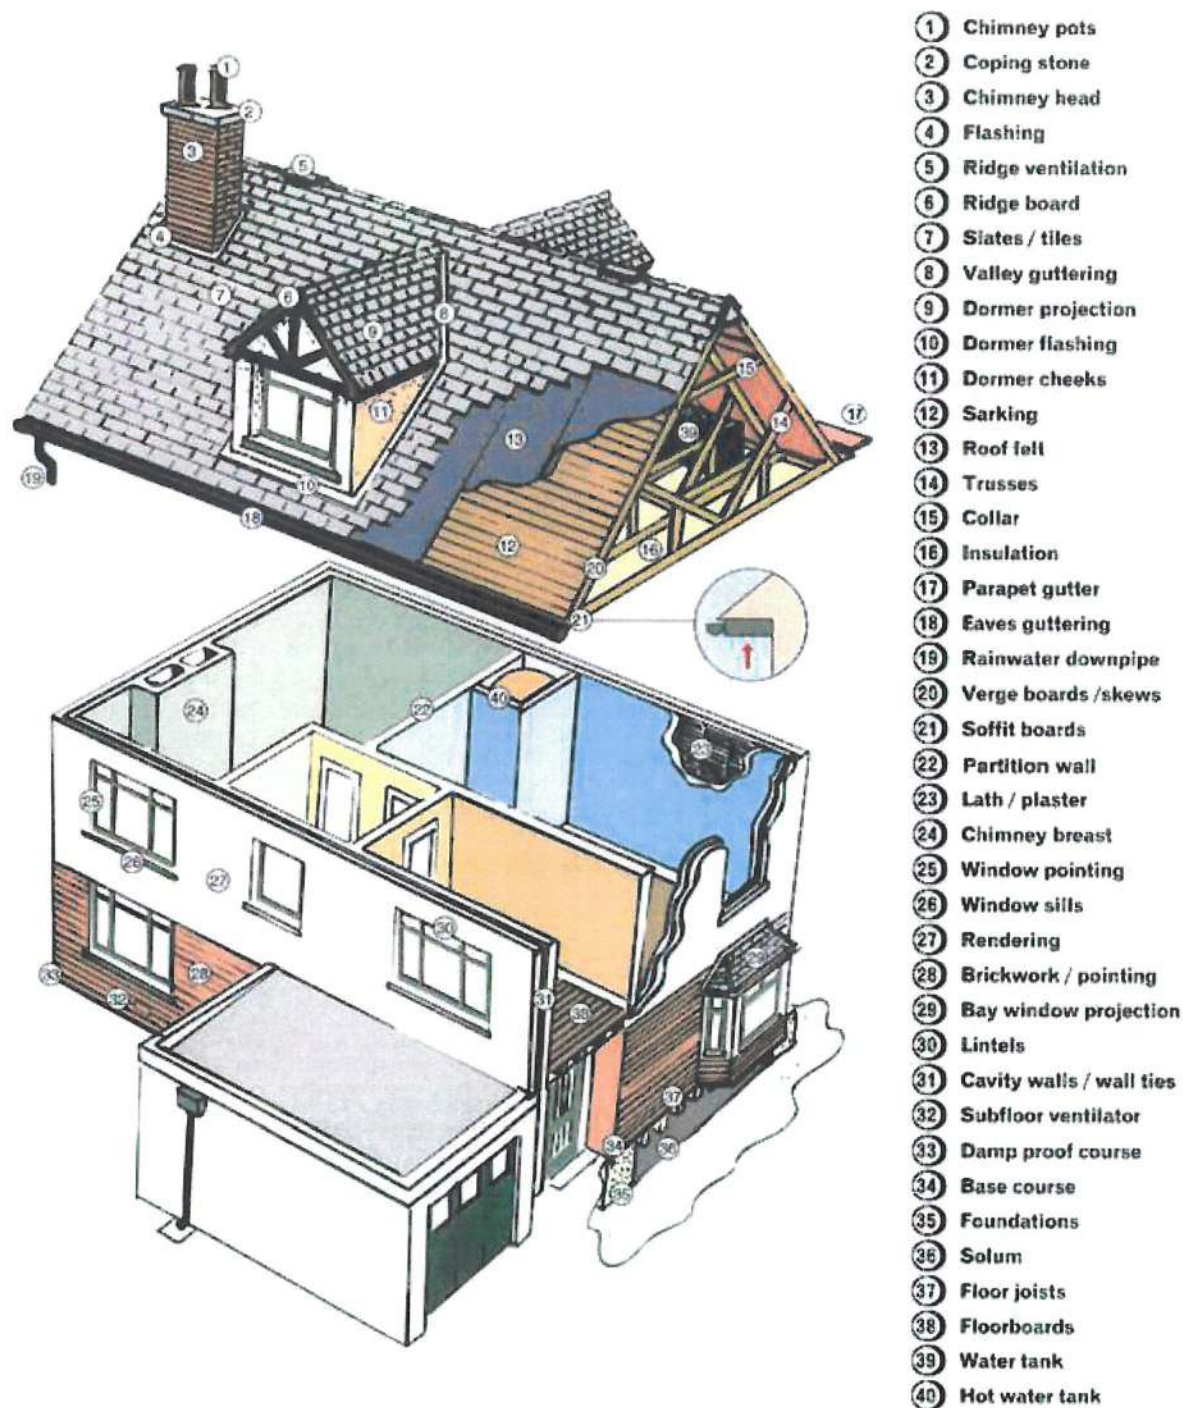
## Sectional Diagram showing elements of a typical house

Reference may be made in this report to some or all of the above component parts of the property. This diagram may assist you in locating and understanding these items.

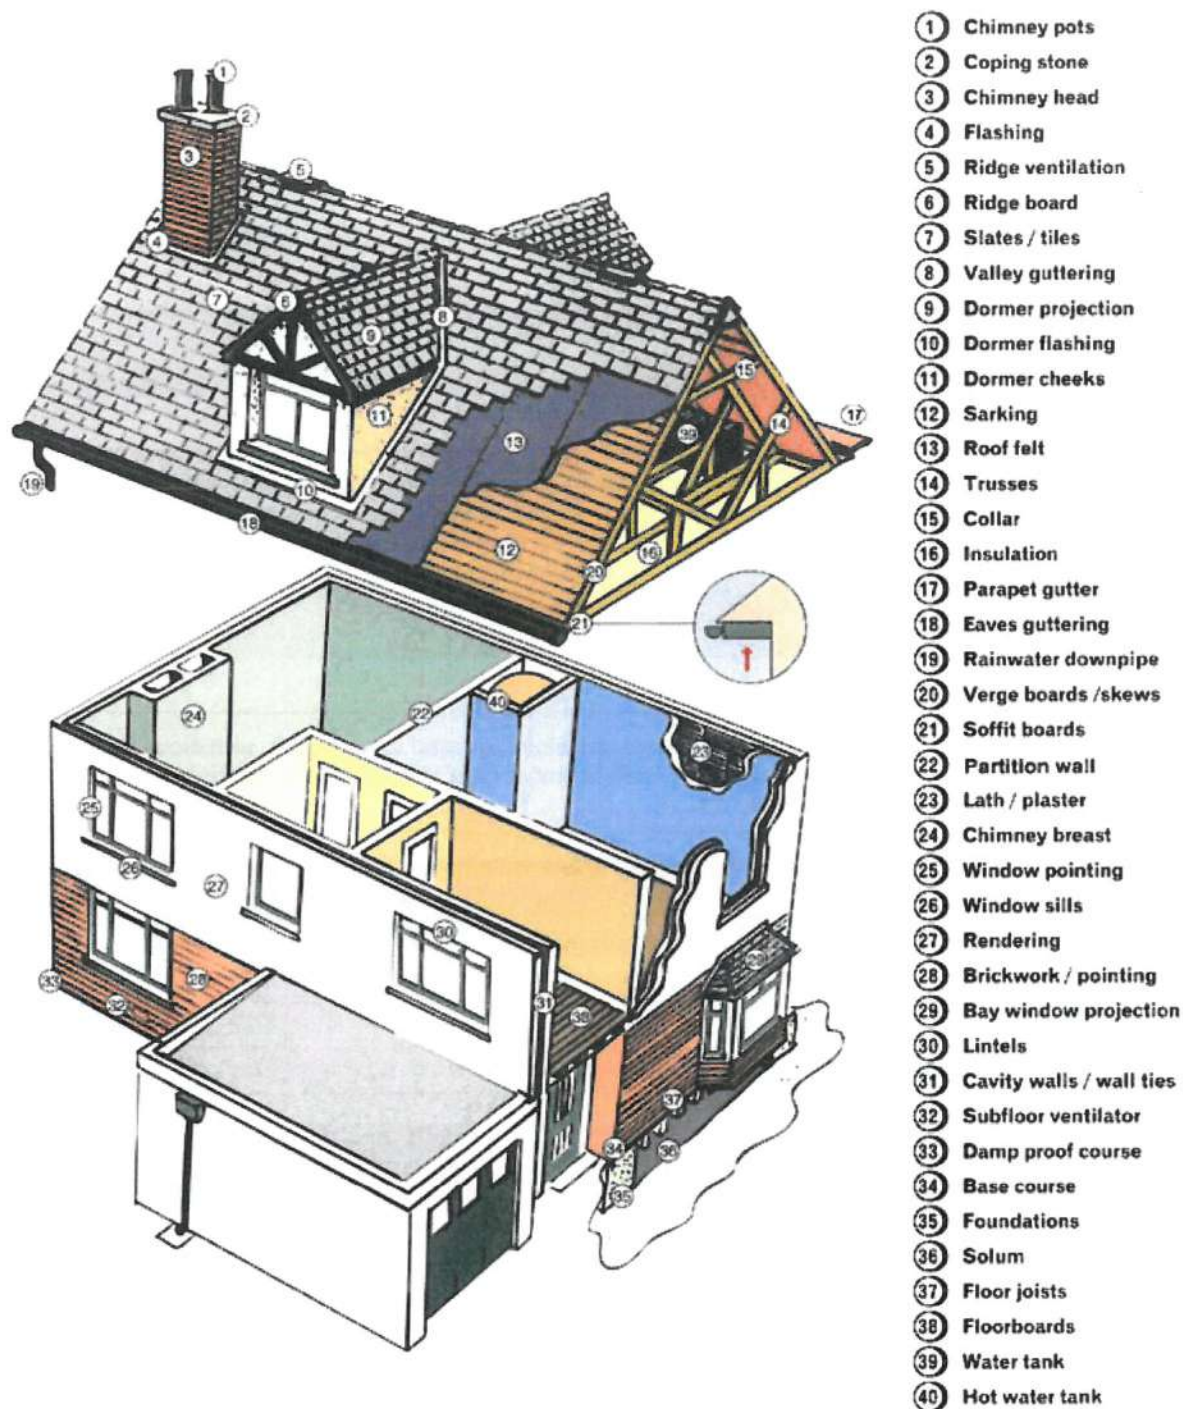
## Sectional Diagram showing elements of a typical house

Reference may be made in this report to some or all of the above component parts of the property. This diagram may assist you in locating and understanding these items.
