# Single Survey

survey report on:

| <b>Property address</b> | 49 Grattan Place,<br>Fraserburgh,<br>Aberdeenshire,<br>AB43 9SD |

| <b>Prepared by</b> | DM Hall LLP |

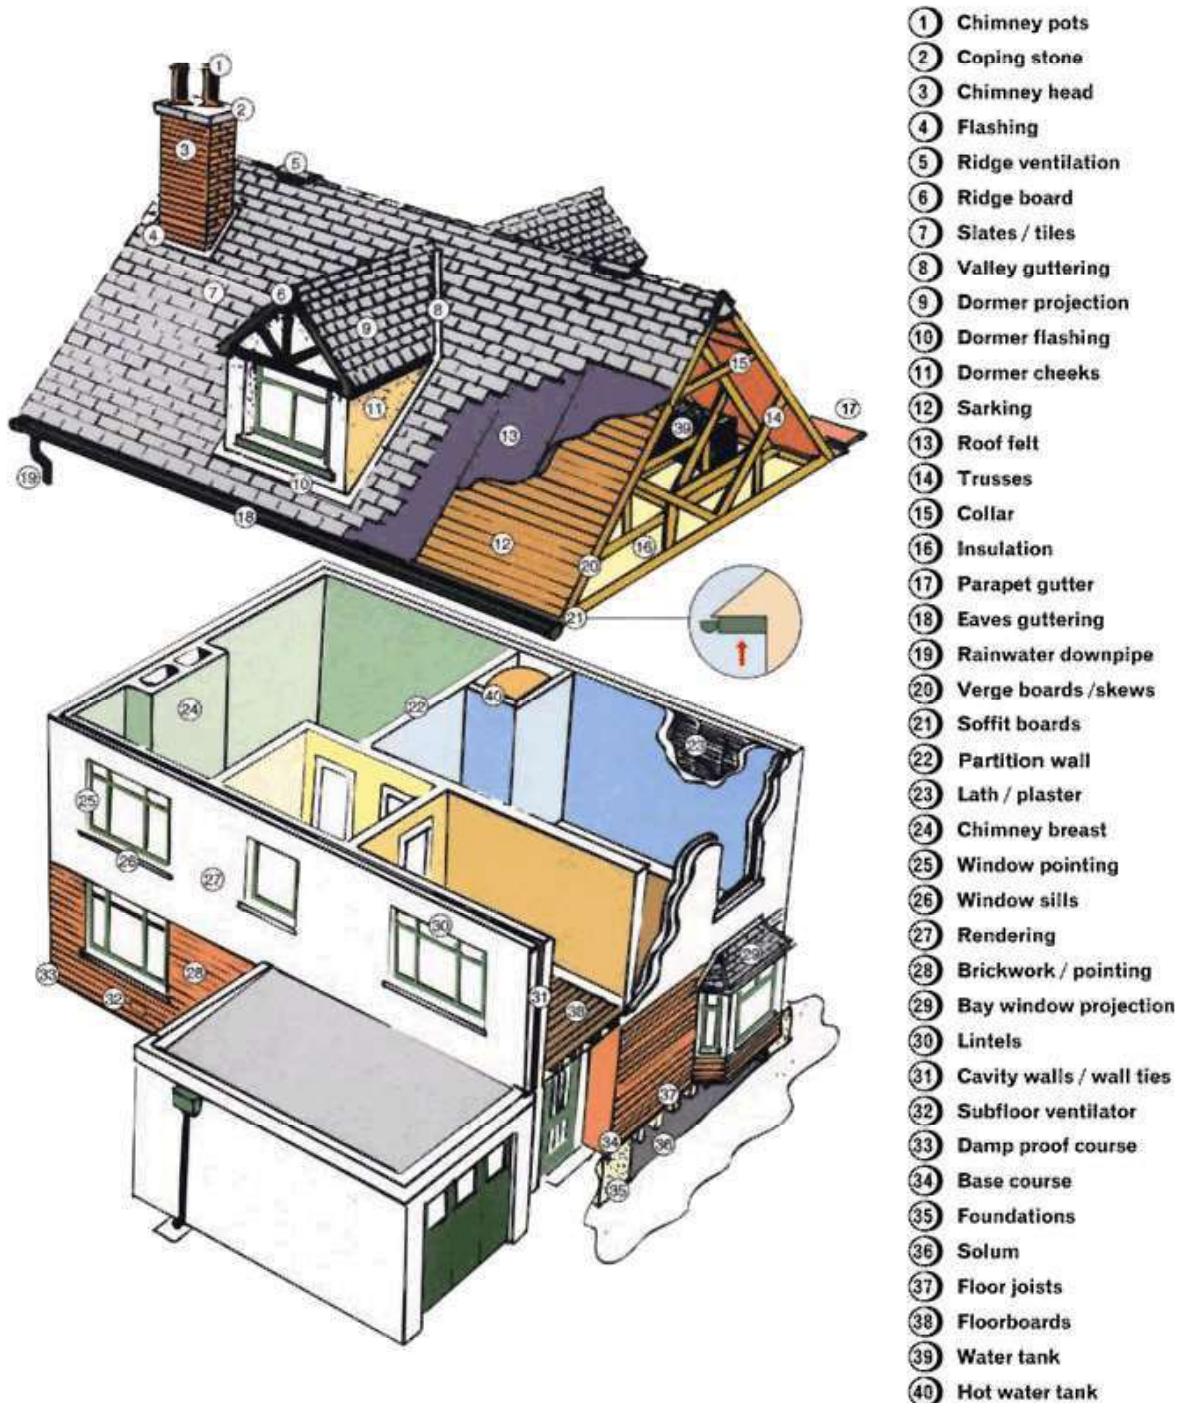
## Sectional Diagram showing elements of a typical house

Reference may be made in this report to some or all of the above component parts of the property. This diagram may assist you in locating and understanding these items.

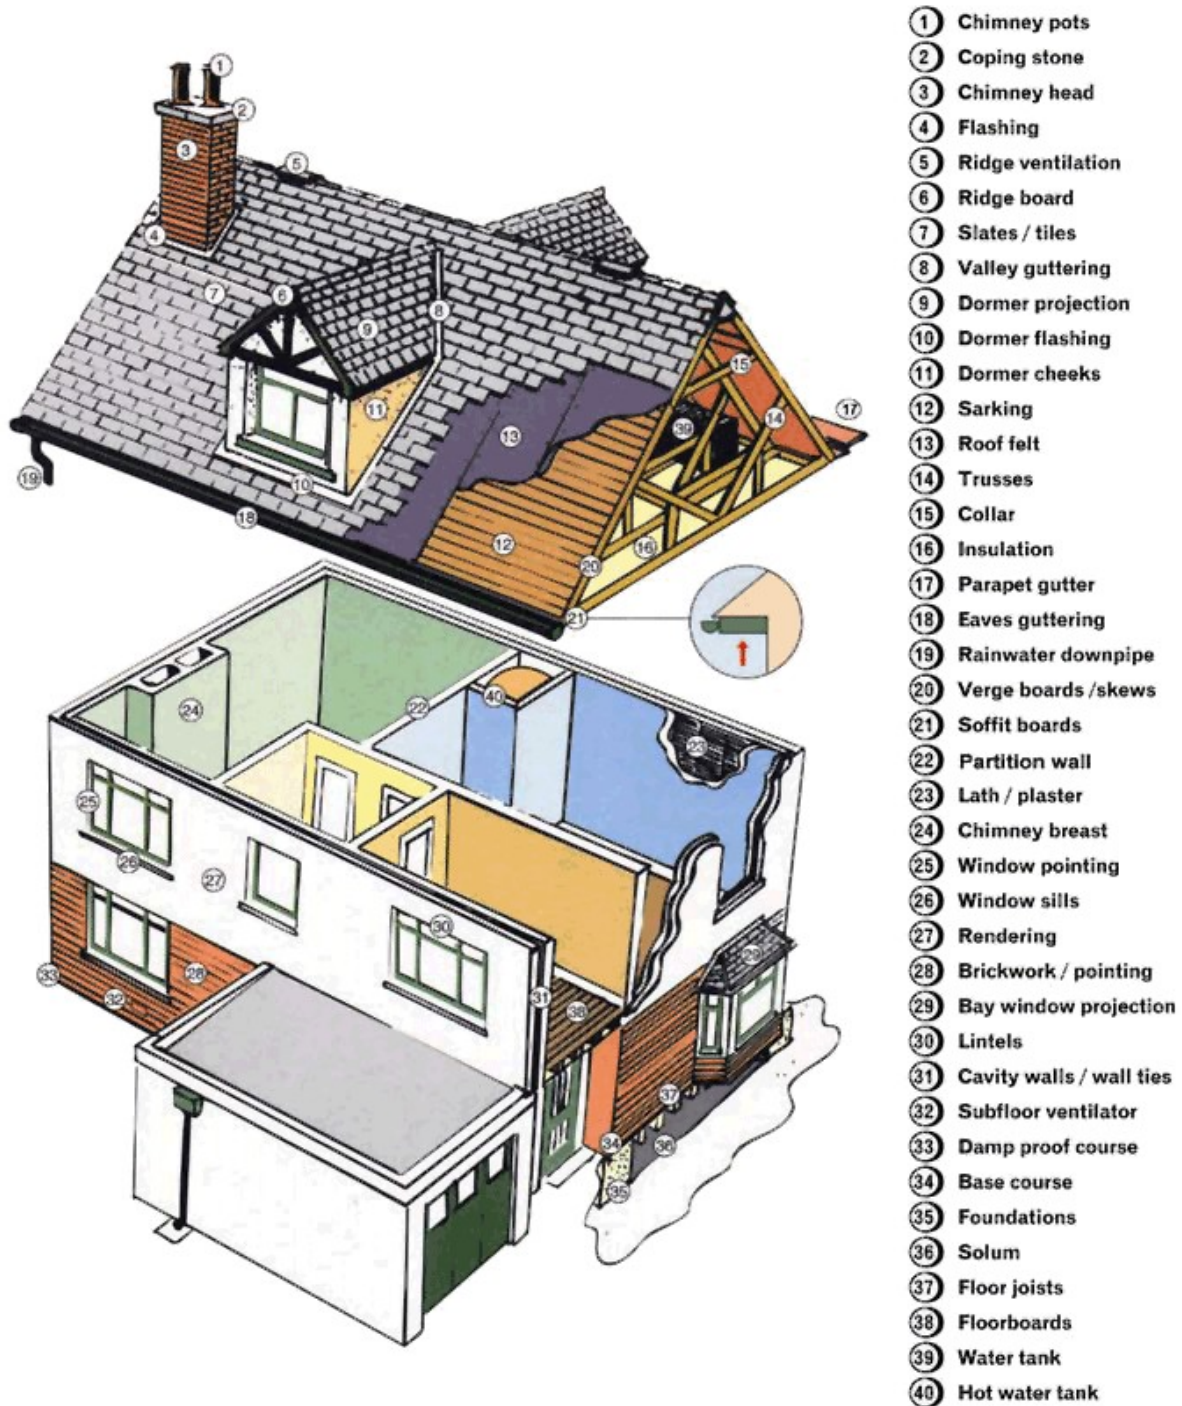
## Sectional Diagram showing elements of a typical house

Reference may be made in this report to some or all of the above component parts of the property. This diagram may assist you in locating and understanding these items.

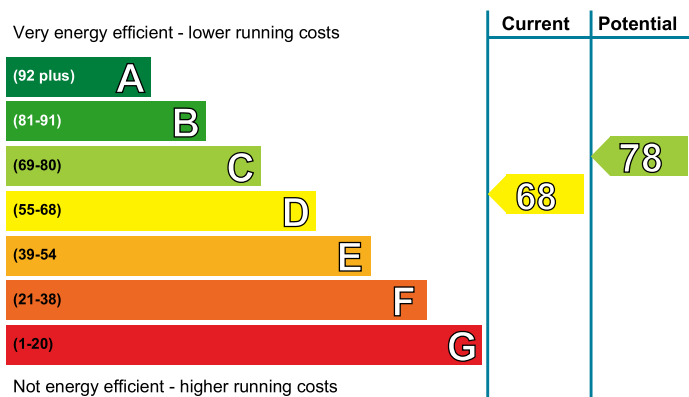
## Energy Efficiency Rating

This graph shows the current efficiency of your home, taking into account both energy efficiency and fuel costs. The higher this rating, the lower your fuel bills are likely to be.

Your current rating is **band D (68)**. The average rating for EPCs in Scotland is **band D (61)**.

The potential rating shows the effect of undertaking all of the improvement measures listed within your recommendations report.

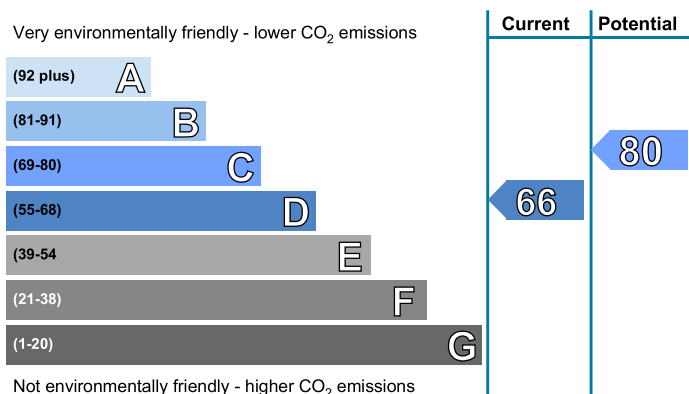
## Environmental Impact (CO<sub>2</sub>) Rating

This graph shows the effect of your home on the environment in terms of carbon dioxide (CO<sub>2</sub>) emissions. The higher the rating, the less impact it has on the environment.
